MISCELLANEOUS PAPER GL-85-21

CRATER REPAIR OF NORTH AUXILIARY AIRFIELD, SOUTH CAROLINA

August 1985

Final Report

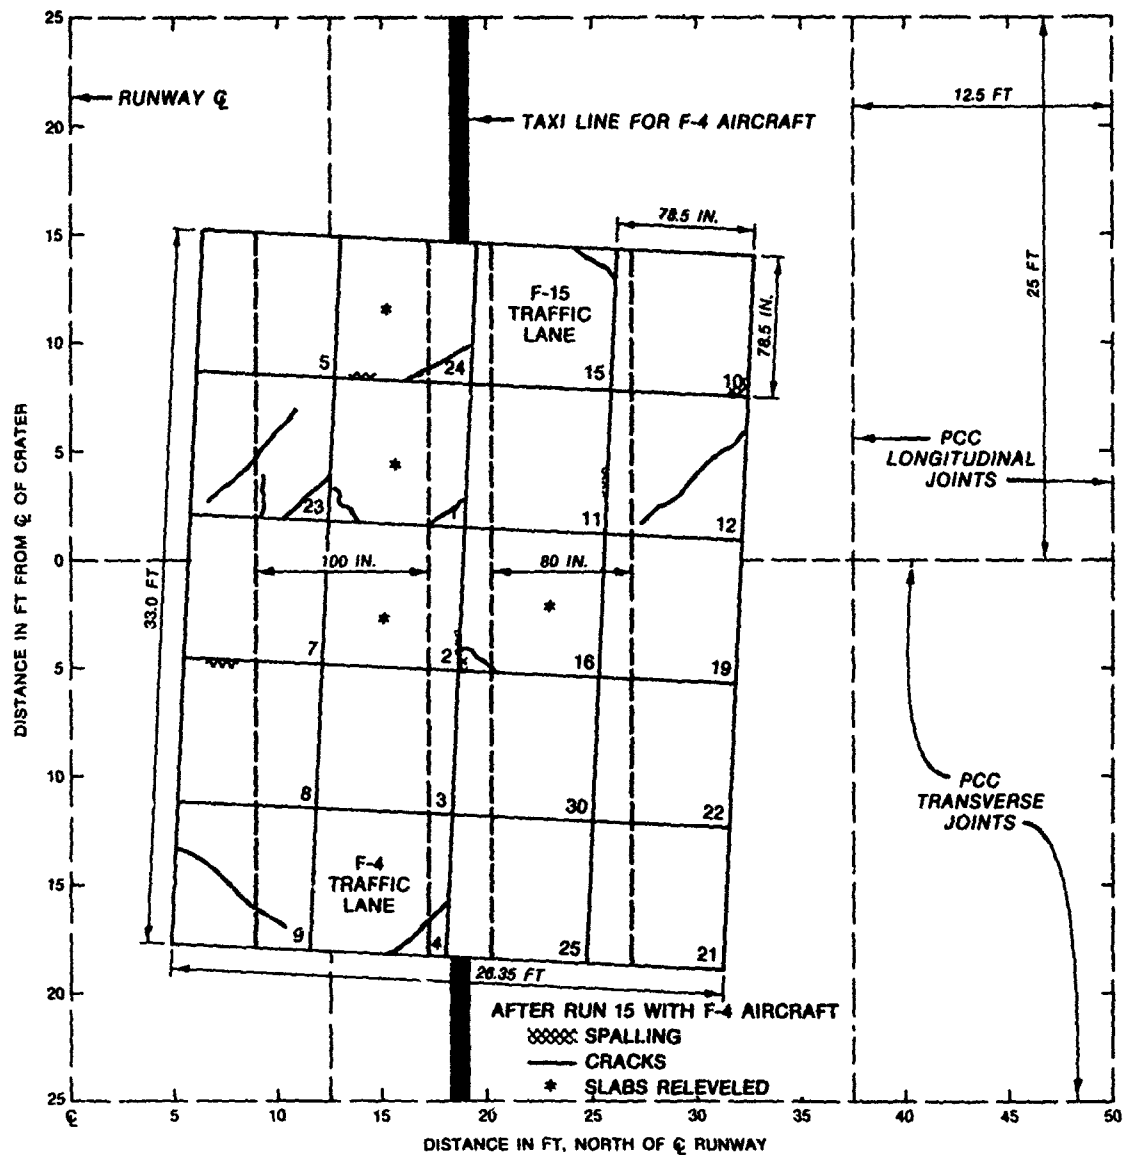
Figure 14. Defects in slabs after run 15, F-4 aircraft

20. After run 15 of the aircraft traffic, four slabs were removed and releved (Figure 14). One slab was removed because the sag measurement exceeded the 2-in. sag criterion (Table 4) two were removed because the sag measurement was 1.75 in. (close to the 2-in. criterion), and one was removed to allow replacing of the Silikal patch (west end of crater) which failed under traffic.

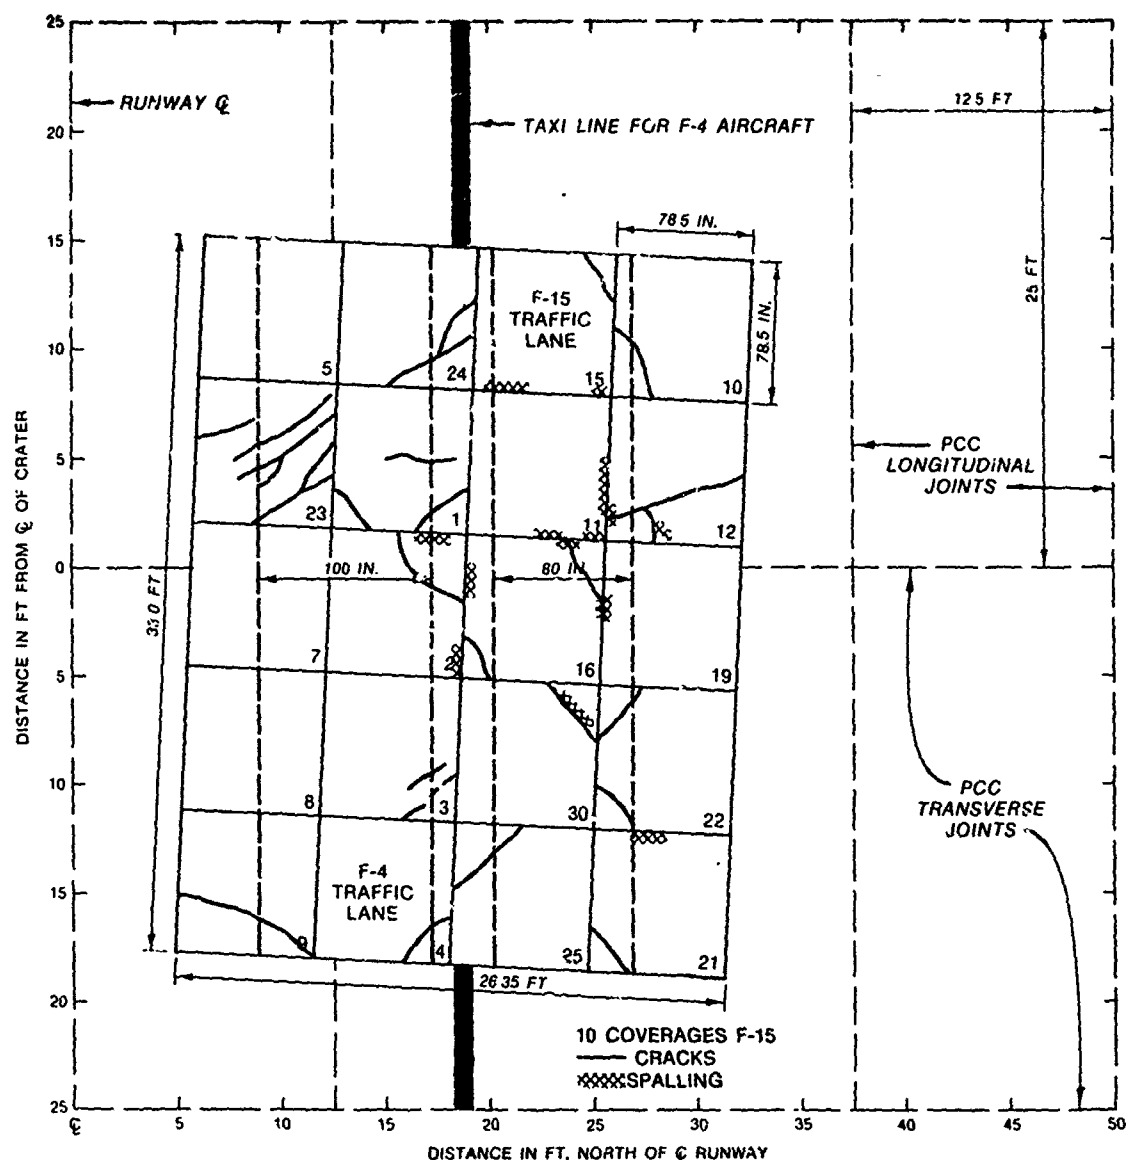
Figure 36. Defects in slabs after 10 coverages of F-15 traffic

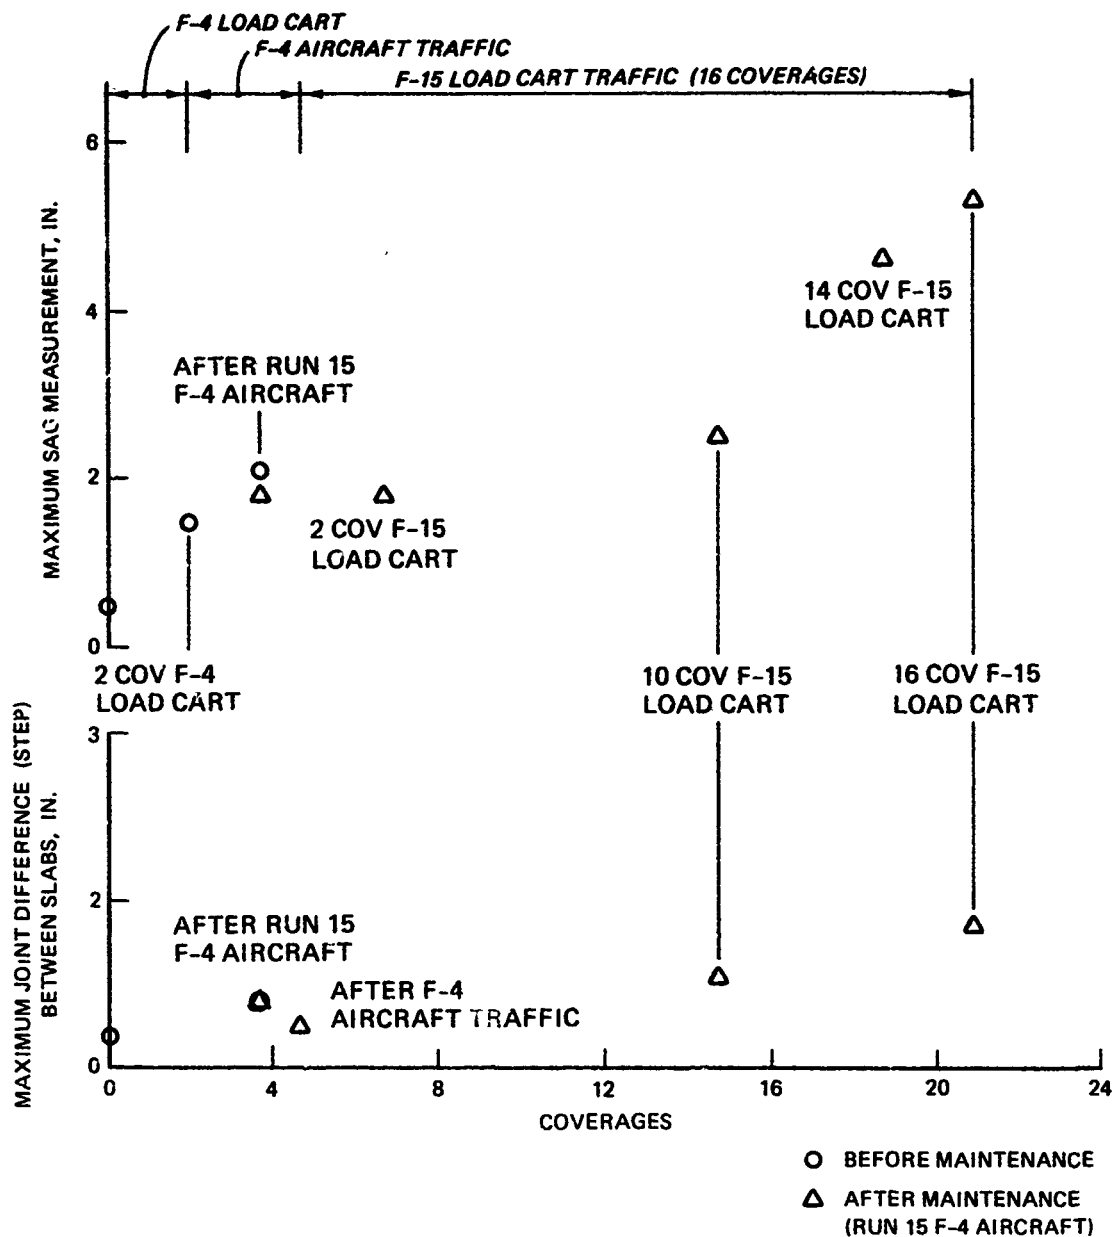
sag measurement had increased to 4.63 in. (Table 4). This measurement was made without the load wheel on the repair. Photo 31 shows the sag measurement along with the spalling on slabs 16, 19, 11, and 12. Traffic was stopped after 16 coverages when a maximum sag of 5.25 in. was measured (Photo 32). The maximum sag measurements and the maximum joint difference (step) between the slabs recorded during all phases of traffic applied on the north side of the crater repair (F-15 traffic lane) are plotted and shown in Figure 37. Photo 33 is a general view of the traffic lane and Photo 34 shows the traffic with a 10-ft straightedge across the traffic lane after the 16 coverages. Figures 28 through 34 contain profile data after the 16 coverages. Figure 38

Figure 37. Maximum sag measurements and maximum joint difference (step) between the slabs for the north side of the crater repair (F-15 traffic lane)

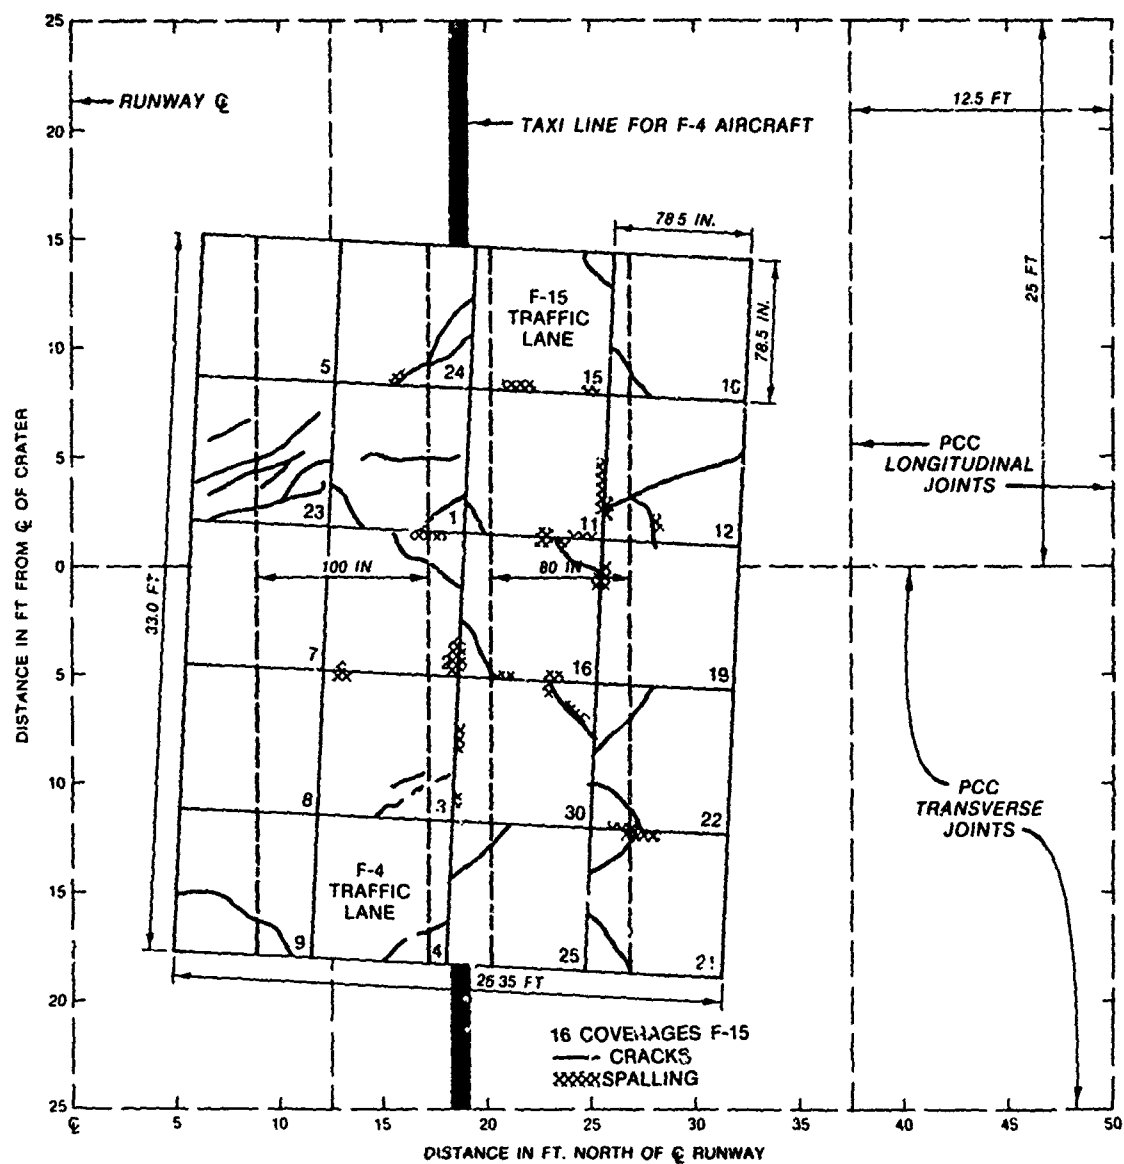
shows the defects and their locations after 16 coverages.

Figure 38. Defects in slabs after 16 coverages of F-15 traffic

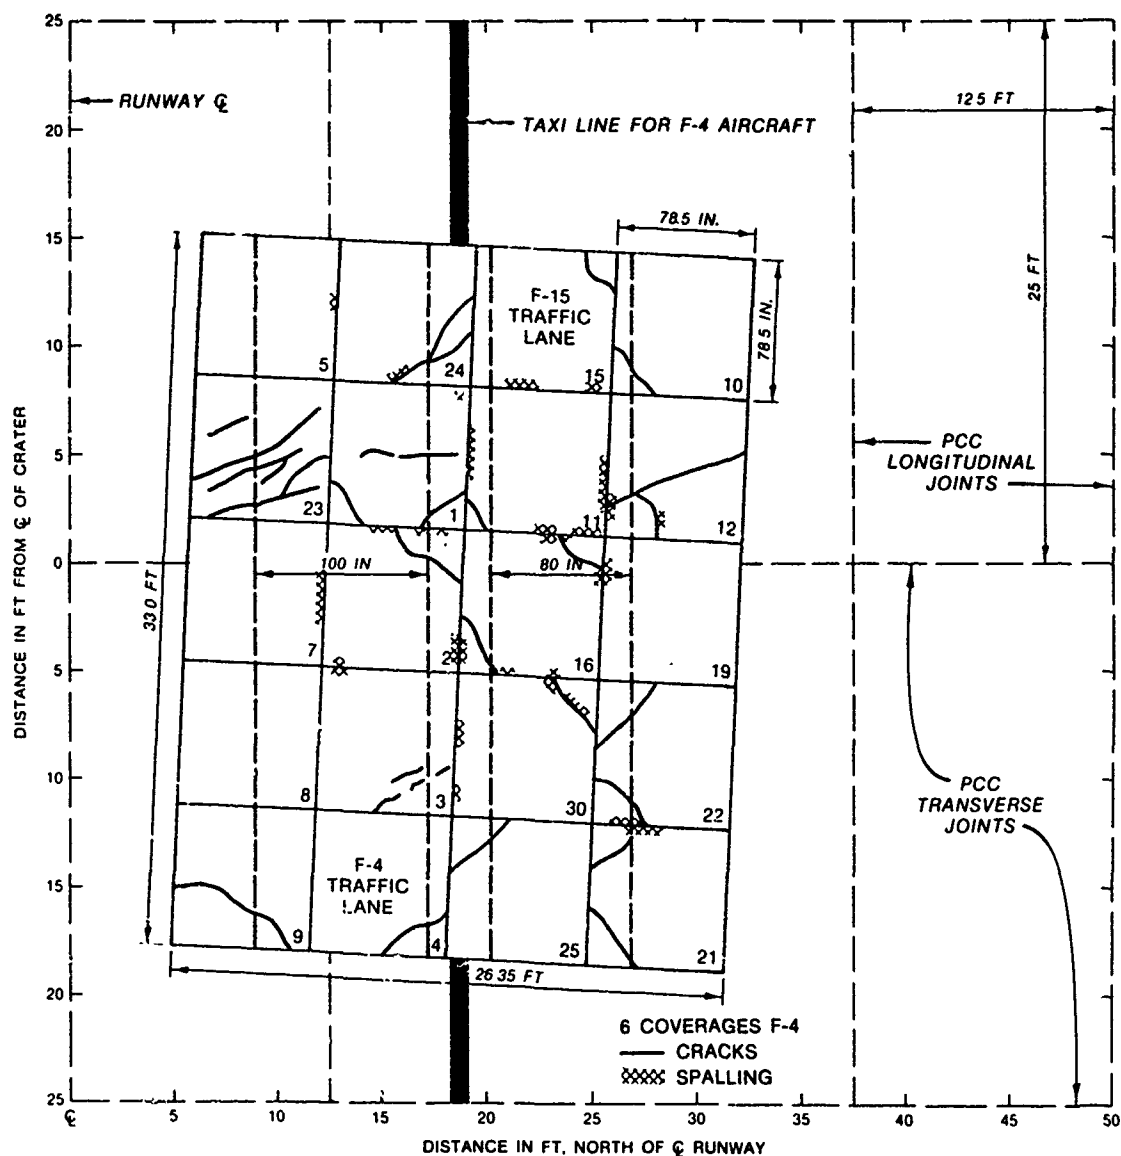
spalling of the PCC was noted (Figure 39). Photo 36 shows the traffic lane after 10 coverages. The spalling that is visible is located on slabs 7, 8, and 3 (Figure 40). The maximum sag measurement was 4.38 in. As traffic continued to 20 coverages, the sag measurement decreased to 4.00 in. Figures 41 through 46 compare profile data at 20 coverages of F-4 traffic with 16 coverages of F-15 traffic (conditions before F-4 traffic was resumed). Figure 47 shows the location of the spalling in the slabs. Photo 37 is a general view of the traffic lane after 20 coverages. At that time, the angle iron band on slab 8 was starting to work loose and the 6-in. PCC (runway, not repair) on the east edge of the crater repair was starting to break up. At

Figure 39. Defects in slabs after 6 coverages of F-4 traffic

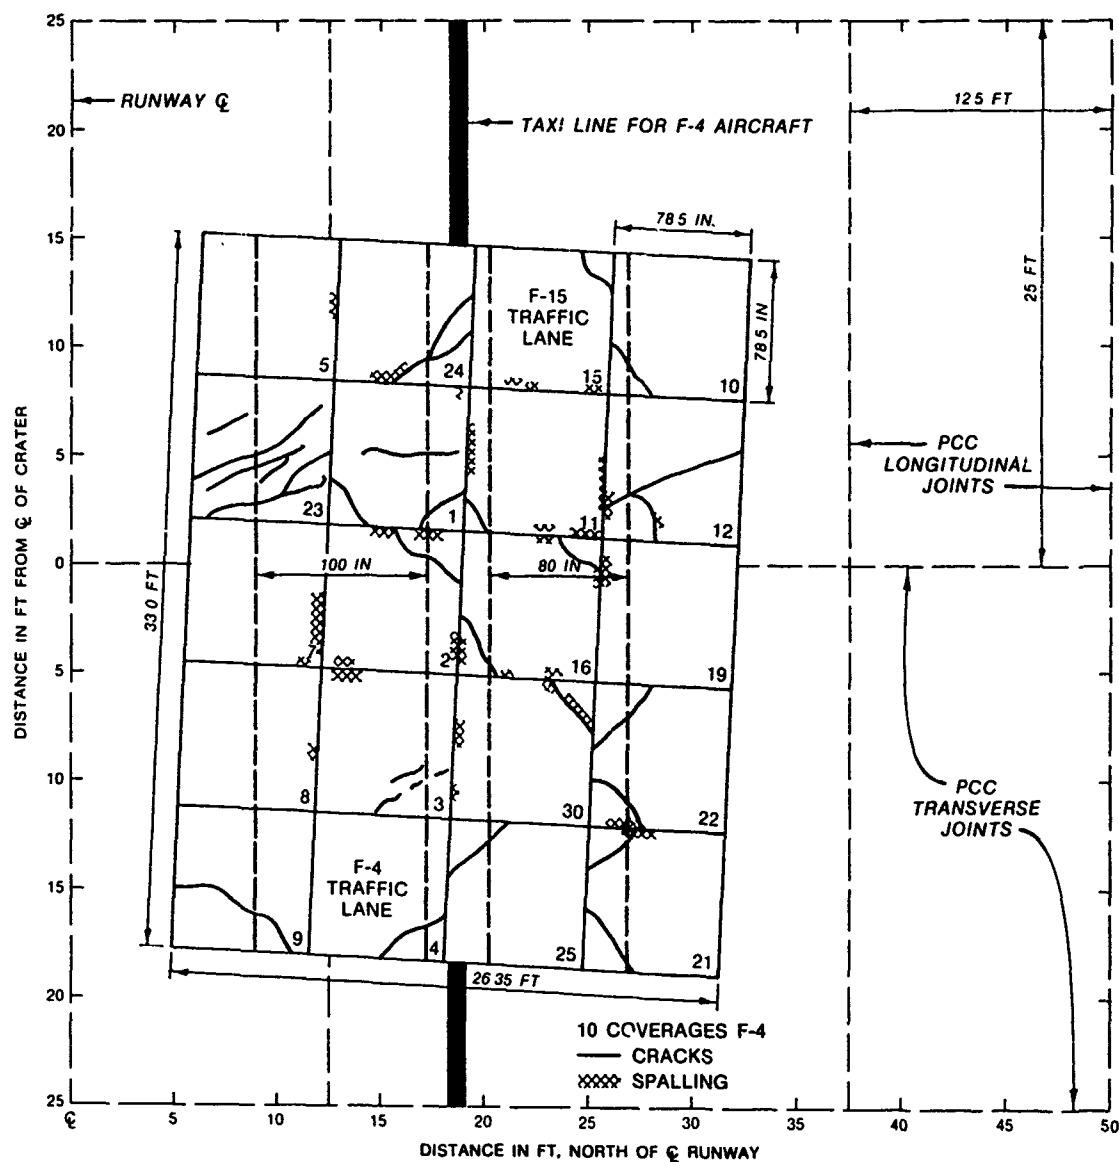
Figure 40. Defects in slabs after 10 coverages of F-4 traffic

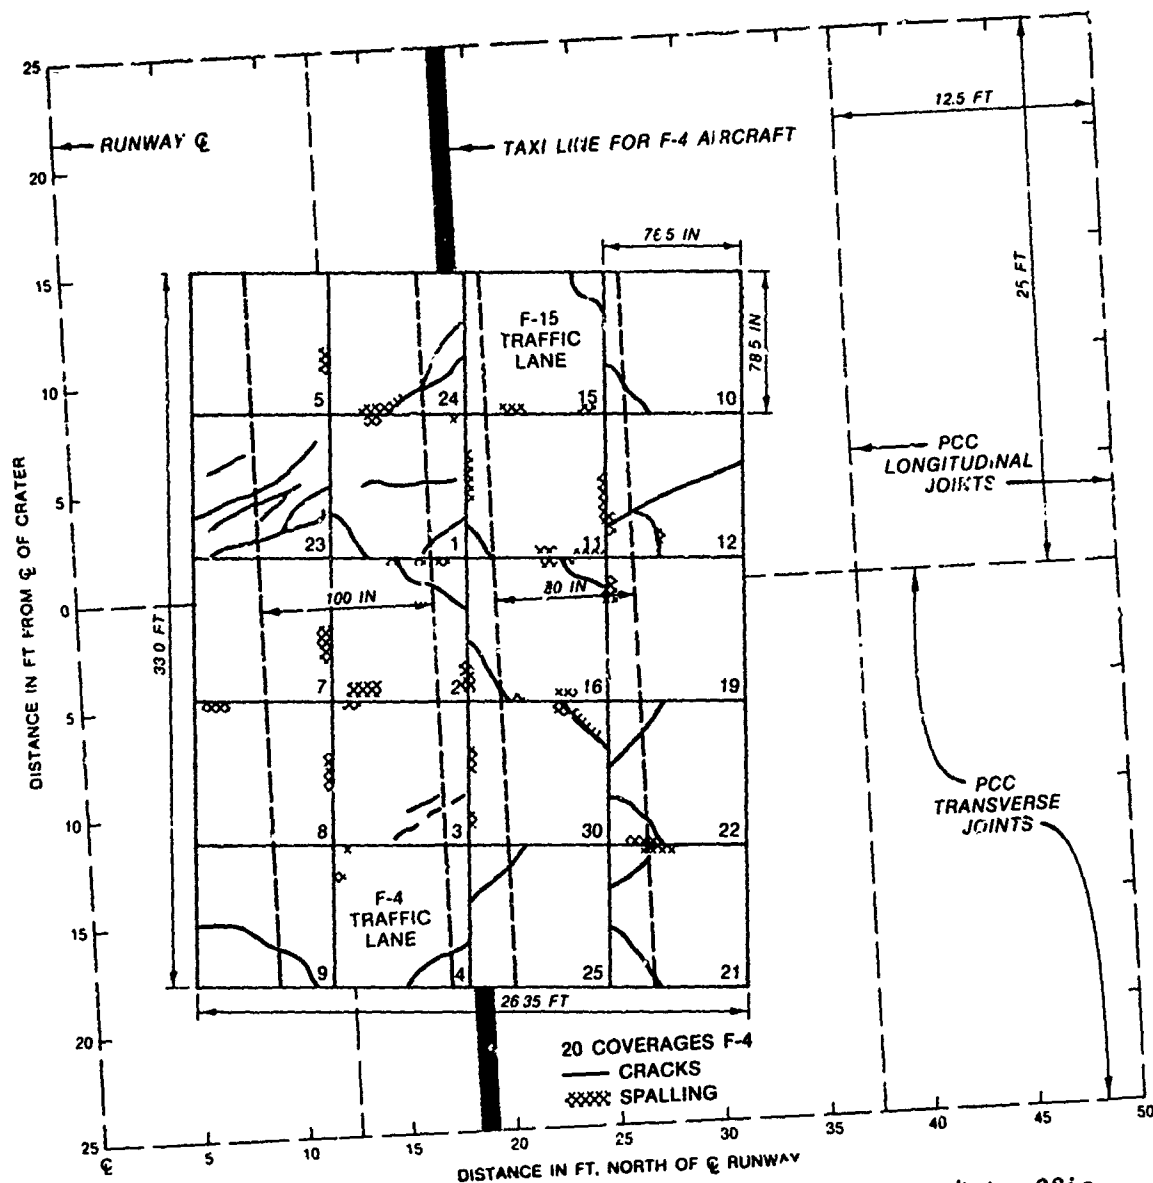
Figure 47. Defects in slabs after 20 coverages of F-4 traffic

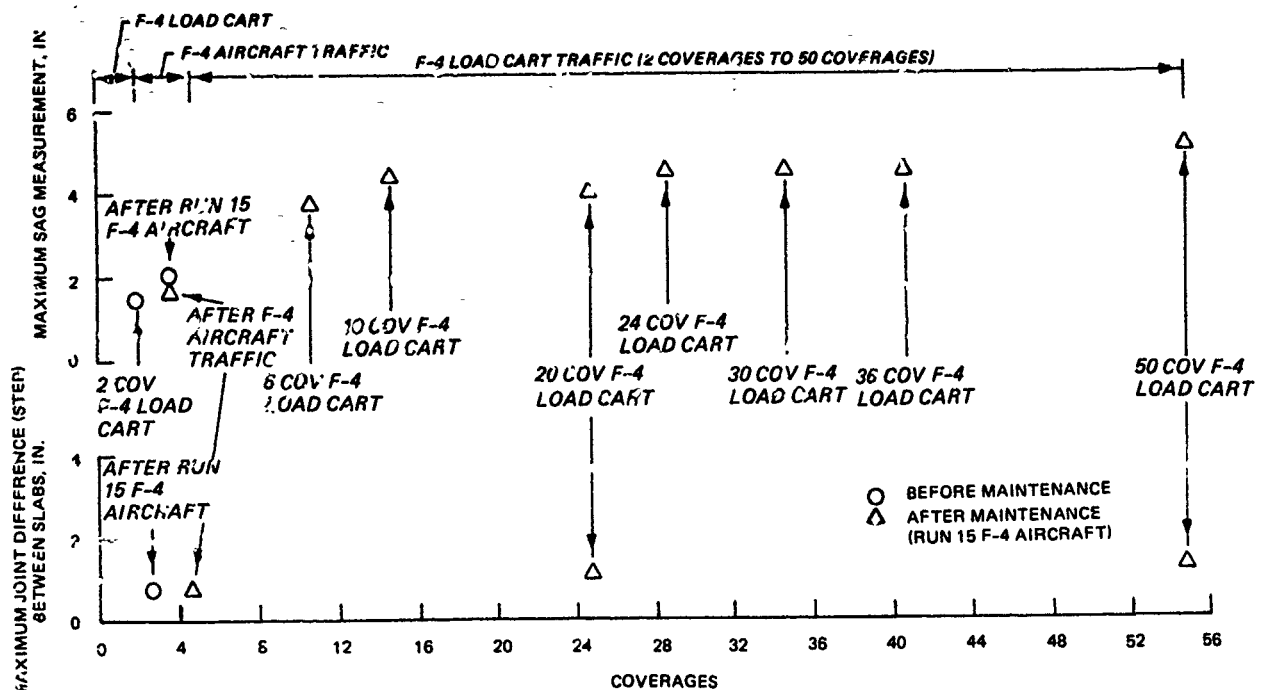
24 coverages, the sag measurement increased to 4.50 in. and remained 4.50 in. through 36 coverages (Table 4). Photo 38 shows the surface condition of the repair after 30 coverages; spalling is evident in this photo. Cracks were also evident in the 6-in. PCC original runway pavement at this time. Traffic was stopped after 50 coverages when the sag measurement was 5.00 in. The maximum sag measurements and the maximum joint difference (step) between the slabs recorded during all phases of traffic applied on the south side of the crater repair (F-4 traffic lane) and plotted are shown in Figure 48. Photo 39 is a general view of the traffic lane after 50 coverages. Spalled areas are visible on slabs 8 (note loose angle iron), 3, and 5 and there was spalling of

Figure 48. Maximum sag measurements and maximum joint difference (step) between the slabs for the south side of the crater repair (F-4 traffic lane)

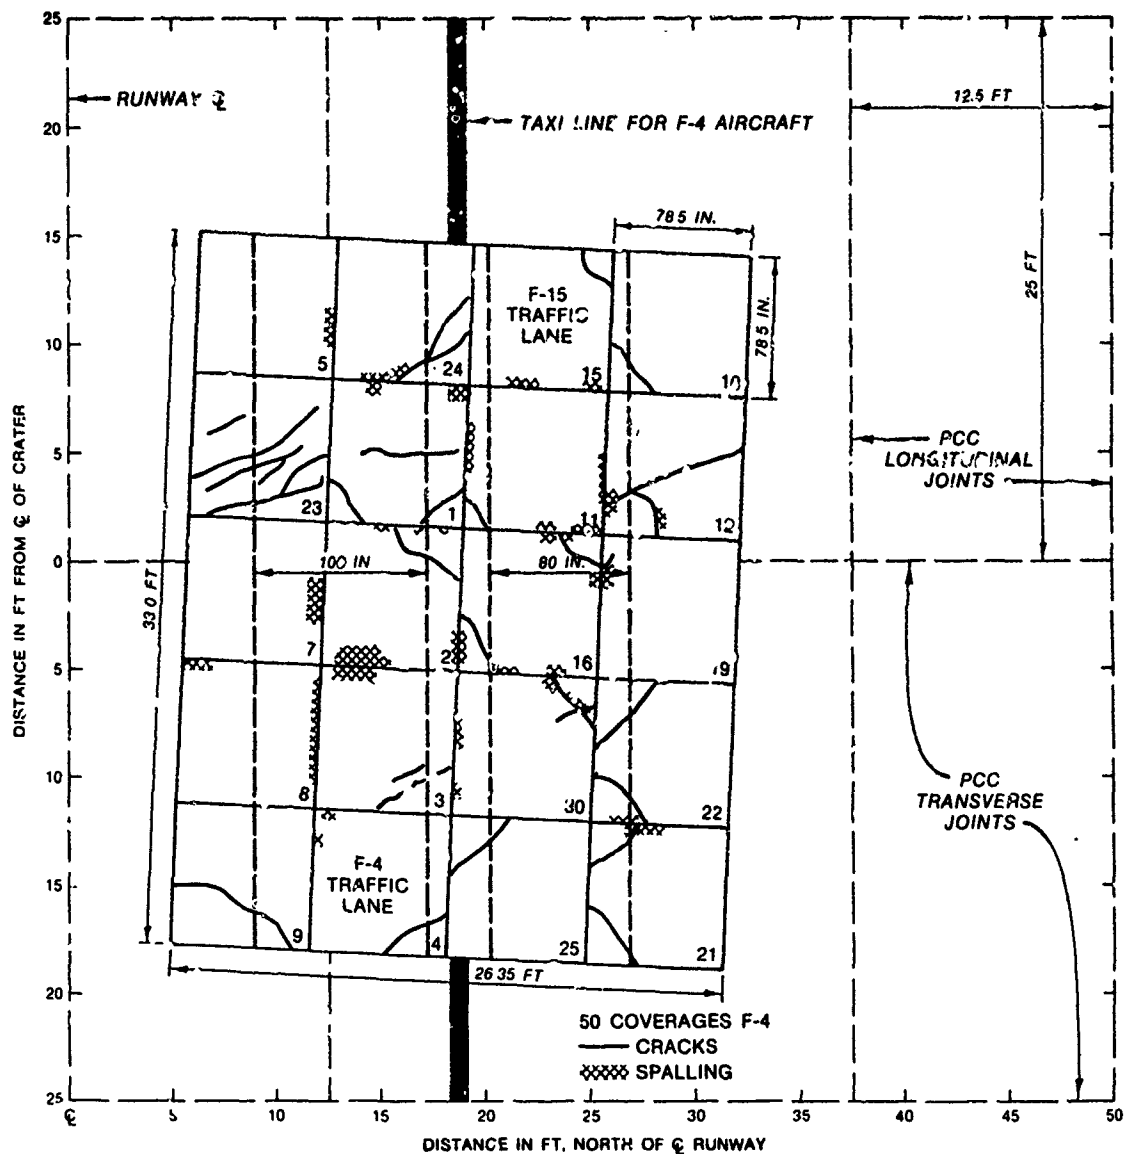
the cracks in the original PCC east of the crater repair. Figure 49 shows the location of all the spalling in the crater repair. There were no breaks or cracks generated in any of the slabs by F-4 load cart traffic. Figures 41 through 46 show profile data (50 coverages) in comparison with data when F-4 load cart traffic was resumed and after 20 coverages.

Figure 49. Defects in slabs after 50 coverages of F-4 traffic

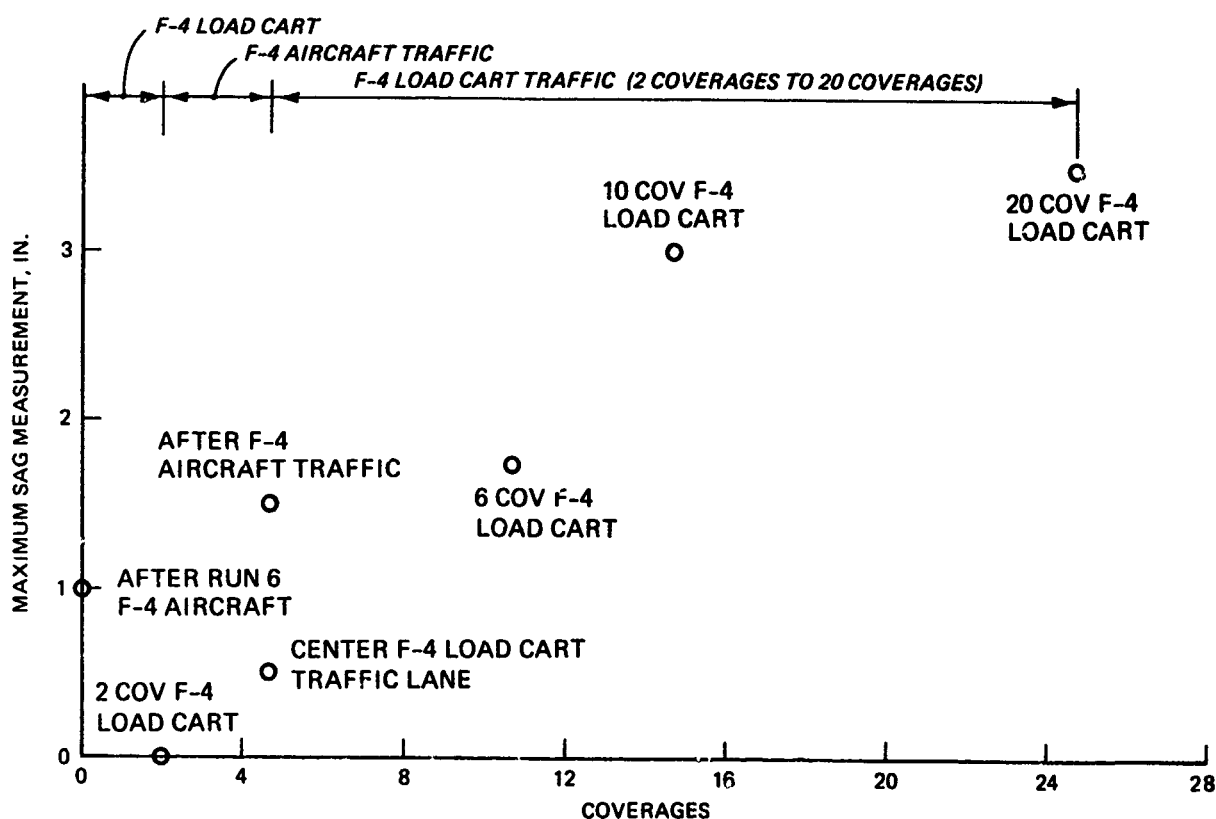
increased as traffic continued. After 16 coverages the sag along the center line of the traffic lane was 2.75 in. Traffic was discontinued after 20 coverages because of high sag measurements and the difficulty of the load cart traversing the test area. The maximum sag measured after 20 coverages along the center line of the traffic lane was 3.0 in. and 3.5 in. along the hinge. The maximum sag measurements recorded during all phases of traffic applied on the south side of the crater repair (F-4 traffic lane) are plotted and shown in Figure 82. Before traffic was stopped, the load cart's pull wheels tended to spin as the load wheel approached and tried to negotiate the transition between the crater and existing PCC pavement. The load cart also leaned from one side to the other as it negotiated this transition. Photo 52 shows a general view of the traffic lane after 20 coverages. After traffic the FOD cover hinge was inspected and found to be torn almost the entire length of the crater and minor spalling of the fiberglass was also observed along the tear. Photo 53 shows a close-up of the torn hinge and spalling. Figures 78 through 81 show profile and cross-section plots taken on the surface of the FOD cover and on the surface of the base material after

Figure 82. Maximum sag measurements for the south side of the crater repair (F-4 traffic lane)

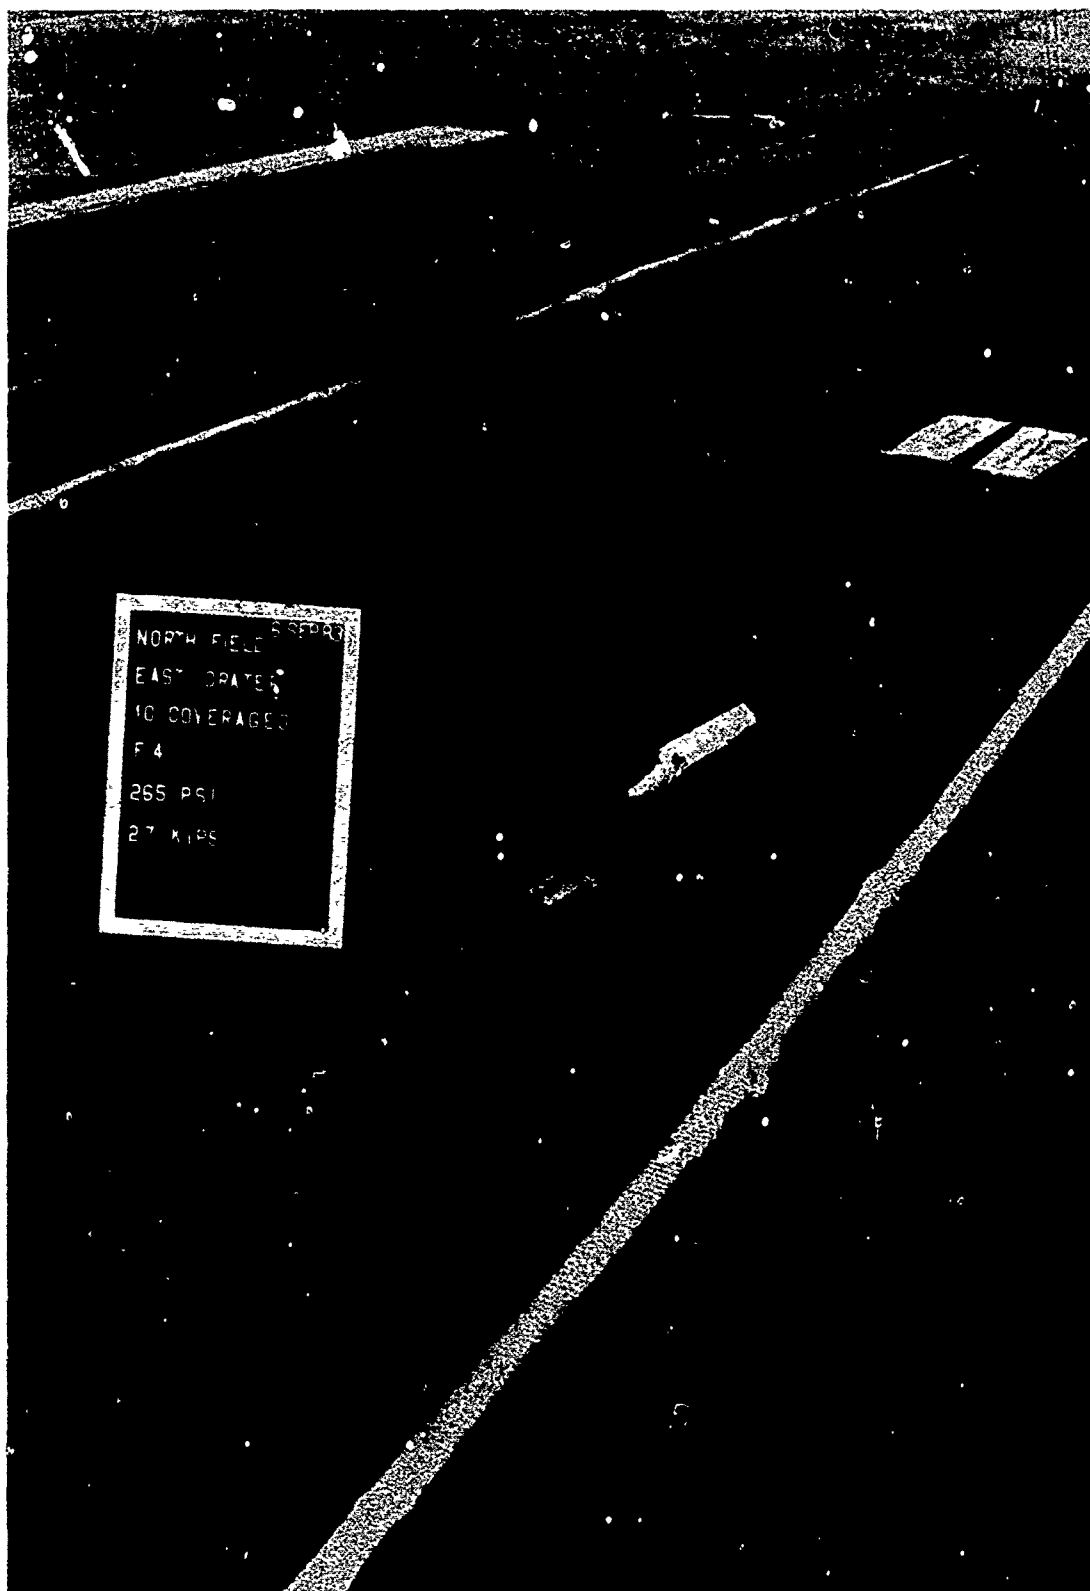
Photo 51. Surface condition along the hinge in the F-4 traffic lane
after 10 coverages, FOD cover repair

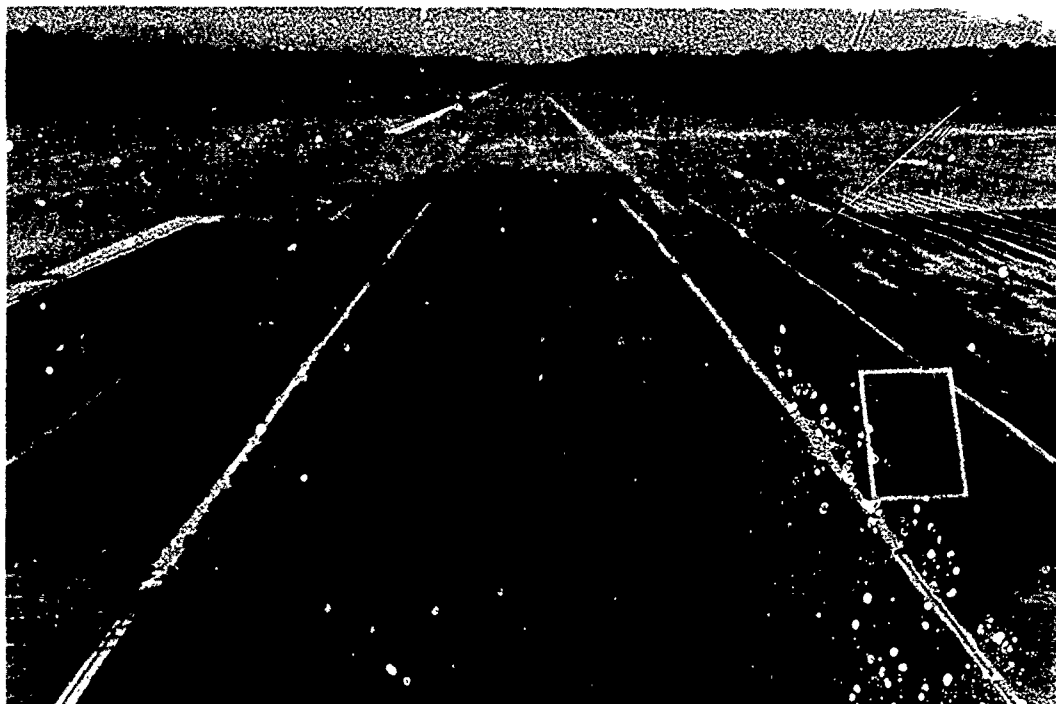
Photo 52. General view of traffic lane after 20 coverages of F-4 traffic, FOD cover repair
